## Cross Hatch Cutter

### Introduction :

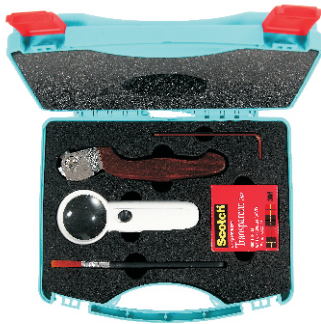
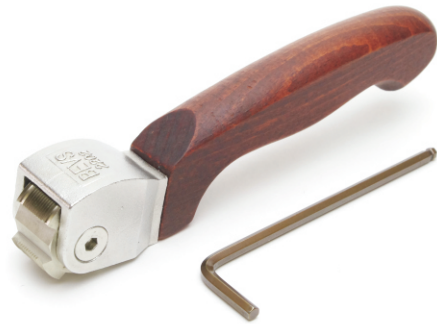
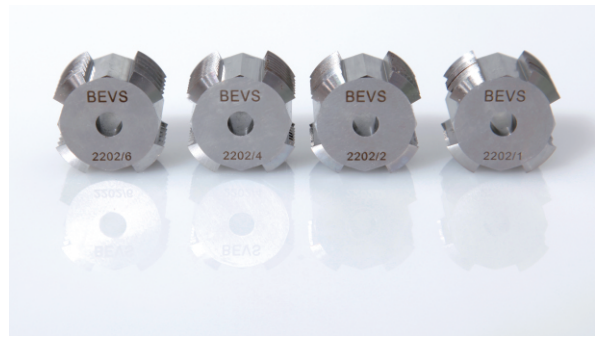
BEVS 2202 Cross Hatch Cutter is designed and manufactured according to ISO 2409-1992, GB/T 9286-98, BS 3900 E6, ASTM D3359 standards.
